Case Study 12 Aeration Lanes Refurbishment

12 Aeration Lanes Refurbishment

Project Duration: February 2024 – April 2025

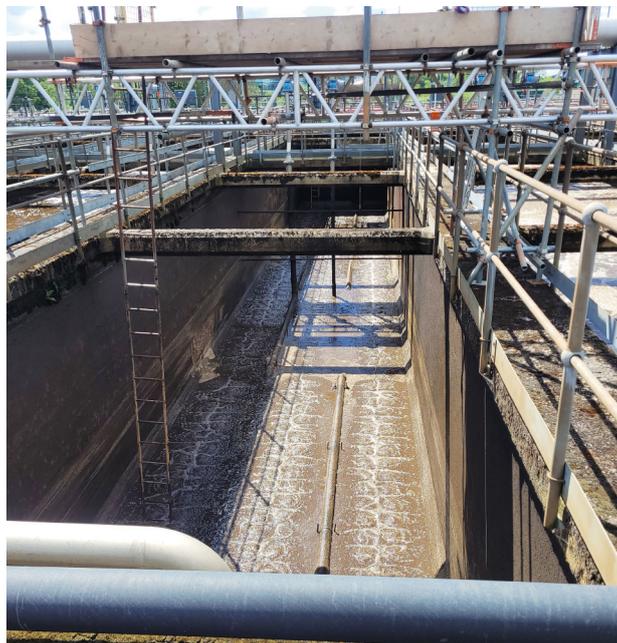
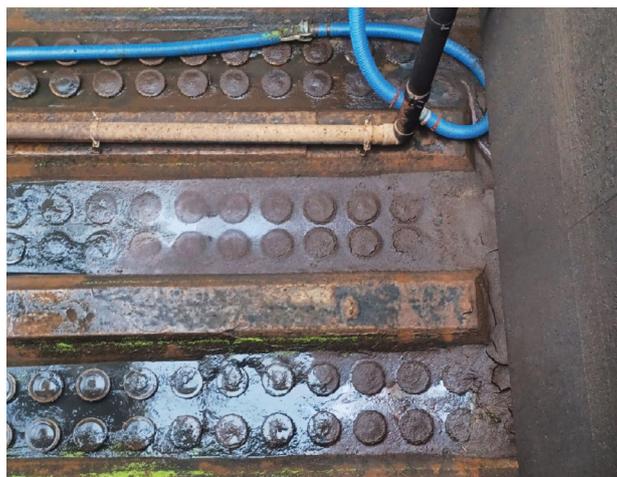
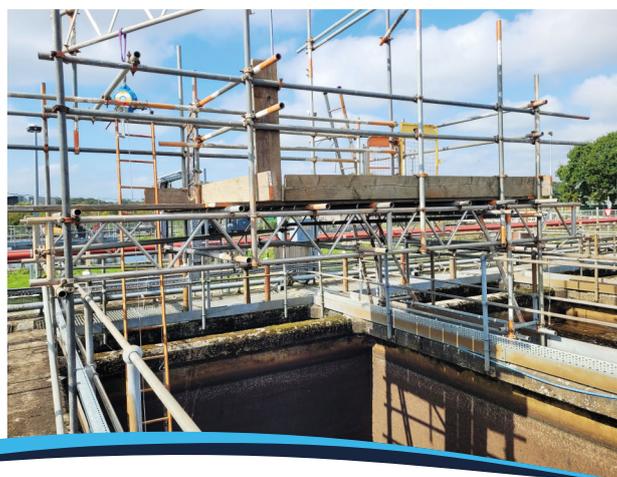
Re-Doming of 12 Aeration Lanes

- ↻ Pipework Installed: 1,896 meters
- ↻ Diffusers Replaced: 4,254 units
 - 2 Small Lanes: 216 m, 504 diffusers
 - 10 Large Lanes: 1,680 m, 3,750 diffusers

- ↻ New PVC pipework and Sanitaire 9" diffusers
- ↻ Leak testing and pattern testing of each lane
- ↻ Proving and recovery periods of 2–4 weeks per lane
- ↻ Minor civil works to support mechanical installation
